PENNSYLVANIA  
**LAUREL DAM**

NDS ID NO. PA-00586  
DER ID NO. 21-25

PENNSYLVANIA DEPT. OF ENVIRONMENTAL RESOURCES  
PHASE I INSPECTION REPORT  
NATIONAL DAM INSPECTION PROGRAM

NAME OF DAM: Laurel Dam  
STATE LOCATED: Pennsylvania  
COUNTY LOCATED: Cumberland  
STREAM: Mountain Creek  
DATE OF INSPECTION: October 31 and November 1, 1978

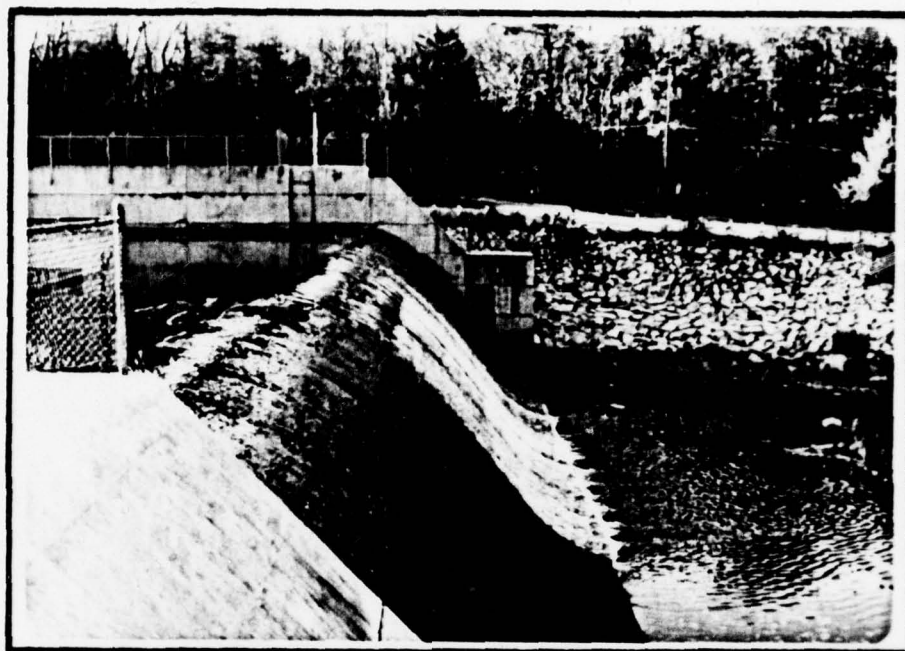
Photograph No. 1

The side channel banks downstream of the dam have grouted riprap for erosion protection. This riprap is in excellent condition.

Looking at left abutment, downstream riprap and reservoir drawdown outlet.

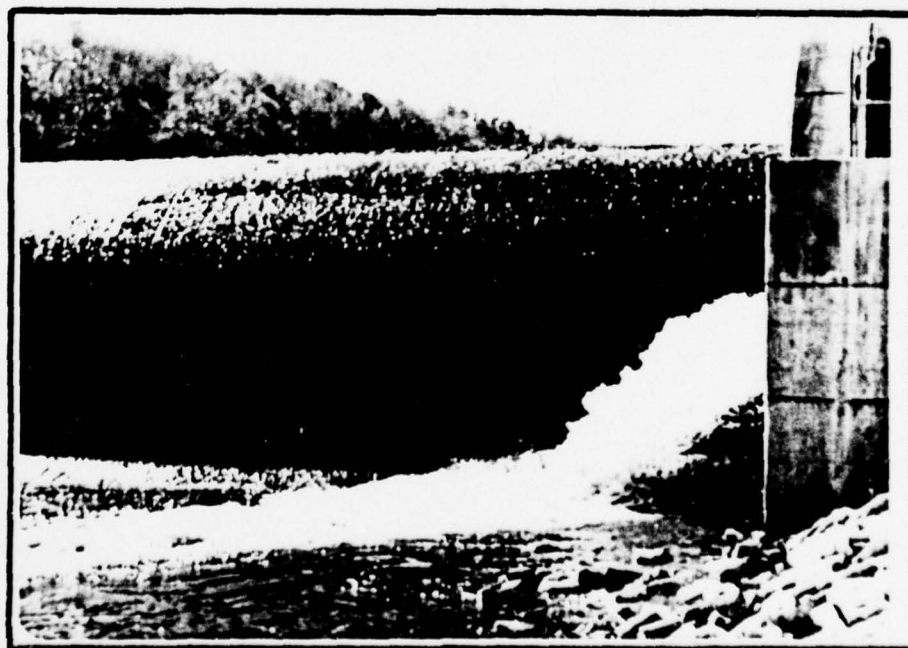
Photograph No. 2

Reservoir drawdown outlet discharging.

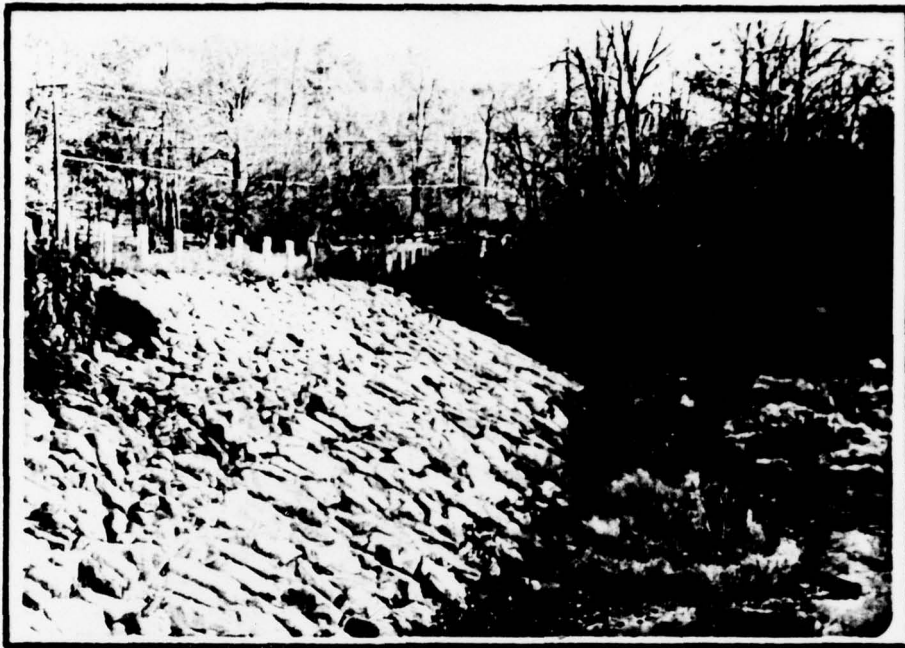
Photograph No. 3

Immediate downstream channel.

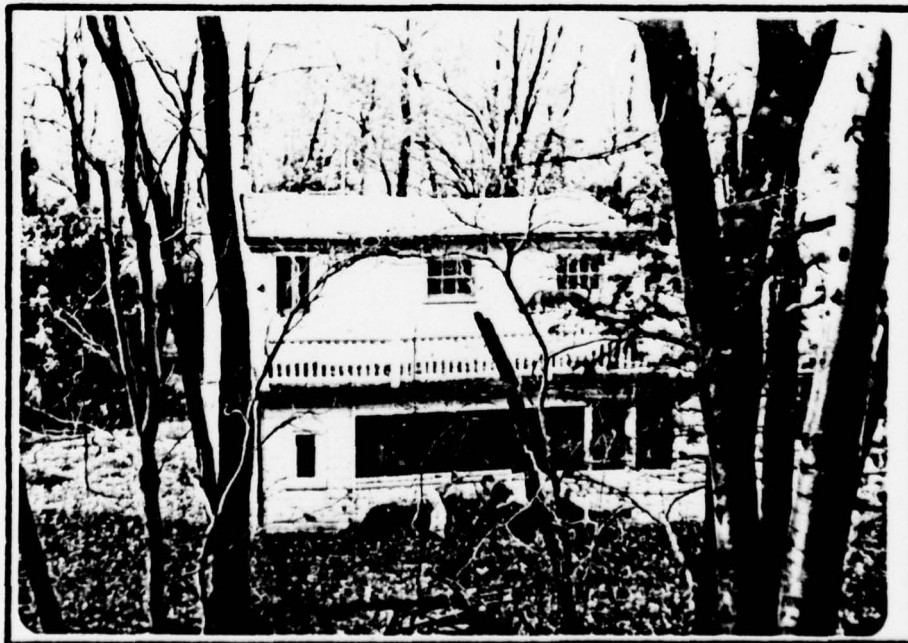
Photograph No. 4

First dwelling (Cottage) downstream.

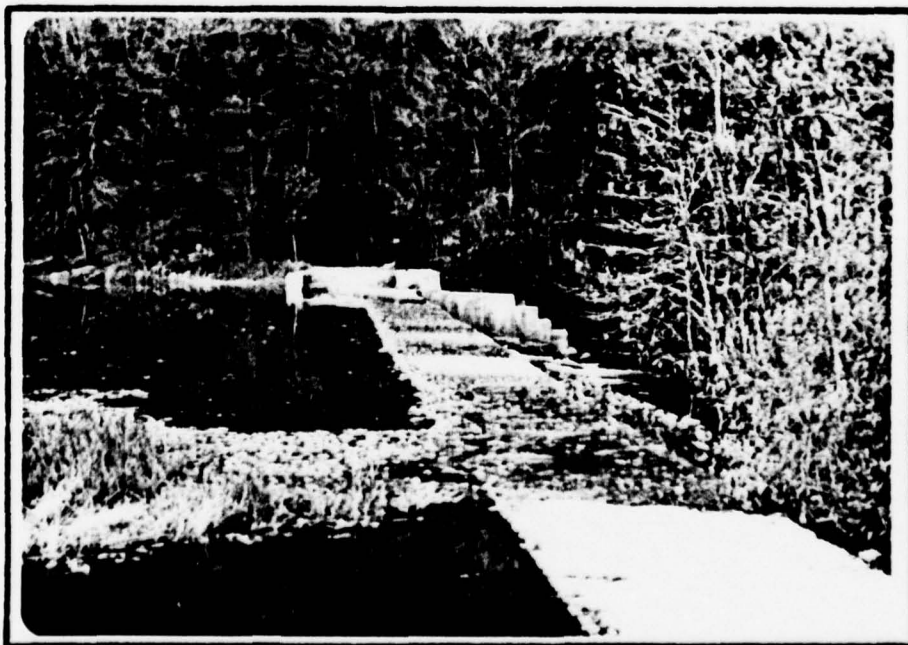
Photograph No. 6

Upper Mount Holly reservoir.

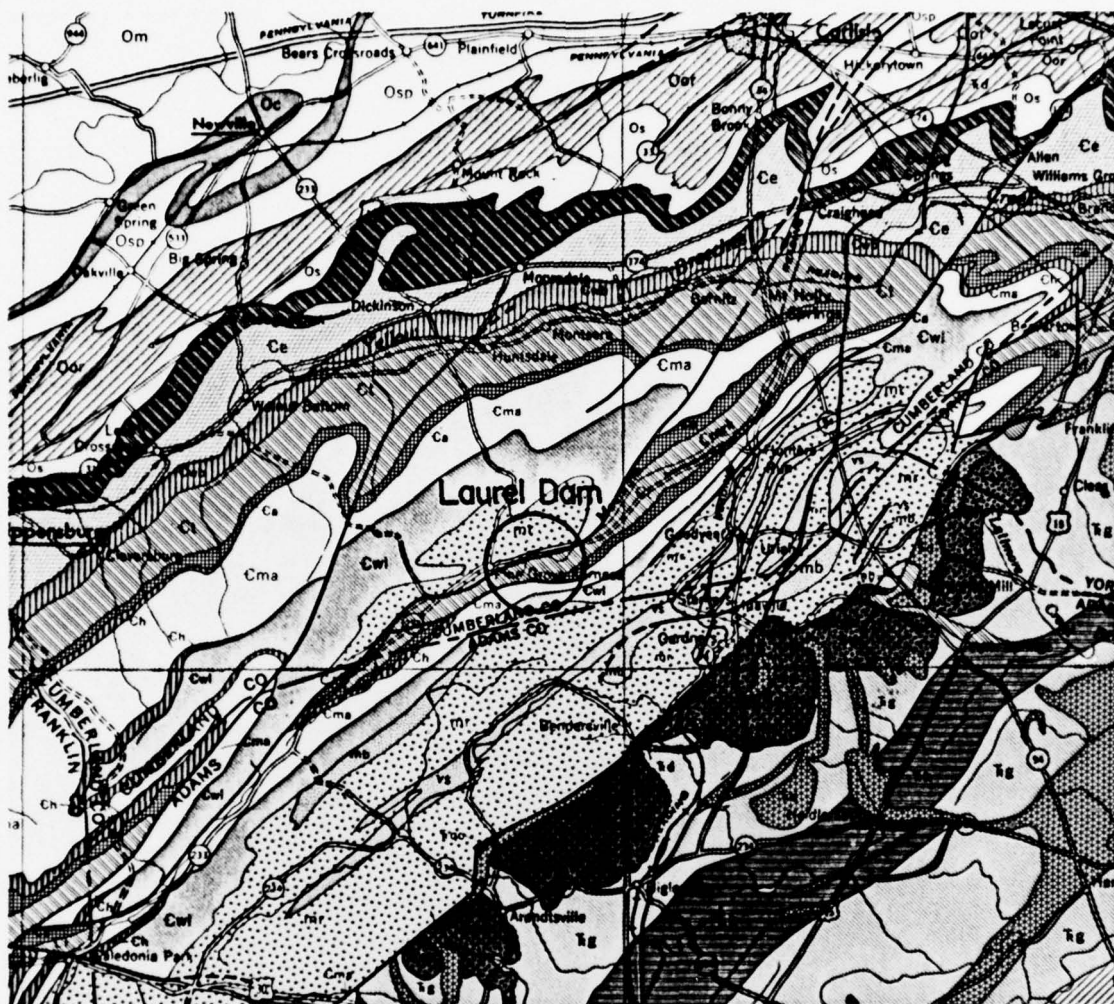
Geologic Map of Laurel Dam Area

The lake and dam lie astride a fault separating a Pre Cambrian aged metarhyolite (mr) from the Cambrian aged Tomstown Formation (Ct). No specific information is available on the metarhyolite, but they are usually fine-grained, red, gray and blue, and have phenocrysts of both quartz and feldspar. There is no bedding, but there may be joints. These may be abundant and closely spaced, but are usually only moderately developed with an irregular pattern. It is highly resistant to weathering, but a thin weathered rind may sometimes have to be removed before it can be utilized as a foundation material for heavy structures. It has good surface drainage and a low magnitude secondary porosity.

Little is known of the fault separating the dolomite from the metarhyolite. There is also a second fault paralleling the first at a distance of about one mile to the south.

A geologic study should be conducted to determine the potential for movement of faults in the area.
